# Back analysis of the Goat Hill North slope failure

**ABSTRACT:** This paper presents the study of a crack that formed on the Goat Hill North Waste Rock Pile of the Molycorp Questa Site. The crack formed during the re-grading of the slope and represented an excellent way to benchmark a numerical model to a failure condition at the site. With the back-analysis it was possible to use a geotechnical software package to back-analyze material parameters based upon possible modes of failure. The back-analysis of the slope failure indicated there are two possible modes of failure: i) a deep-seated failure through a relatively weak layer (rubble or colluvium layers) or ii) failure through the rock pile material. It appears unlikely that the crack observed on October 2004 is due to a failure plane through rock pile material alone. If this were the case, the resulting model-determined soil parameters ( $\phi = 18^\circ$ , cohesion = 150 kPa) differ significantly from the *in situ* testing program. It appears likely that the observed slope failure was the result of sliding along a deep-seated weak layer beneath the rock pile material and above the bedrock layers. The resulting material para

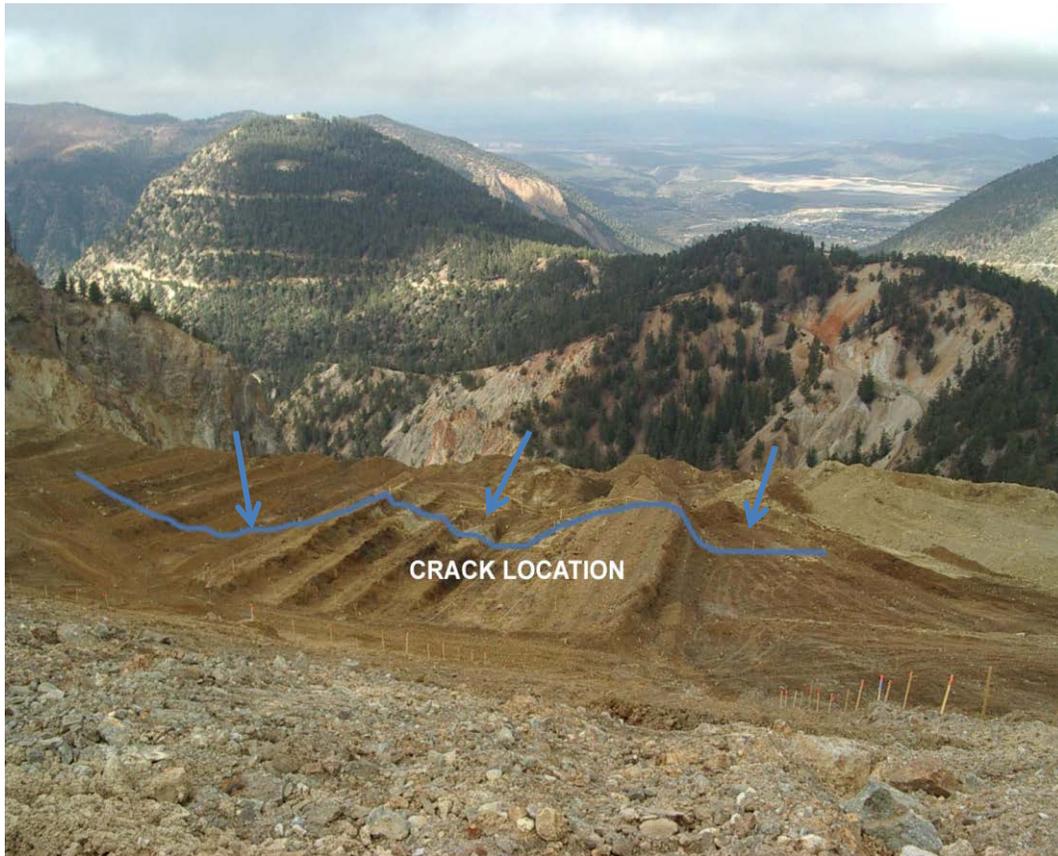
The slope had been pushed in a convex arc out from the original slope of the mountain in order to ultimately flatten the slope of the GHN pile and reduce a slope failure risk. Trenches were excavated through undisturbed zones of the original rock pile during the slope destruction process in order to provide insitu field testing / sampling opportunities for the Questa Waste Rock Pile Weathering Study. The crack formed an arc through the excavated trenches in a manner opposite to the lip of the slope. A view of the crack as highlighted from a position directly above the slope may be seen in Figure 2. The crack was marked with stakes for visualization purposes.

Figure 2 Location of the crack as viewed from up the 2:1 slope (crack highlighted by thick blue line)

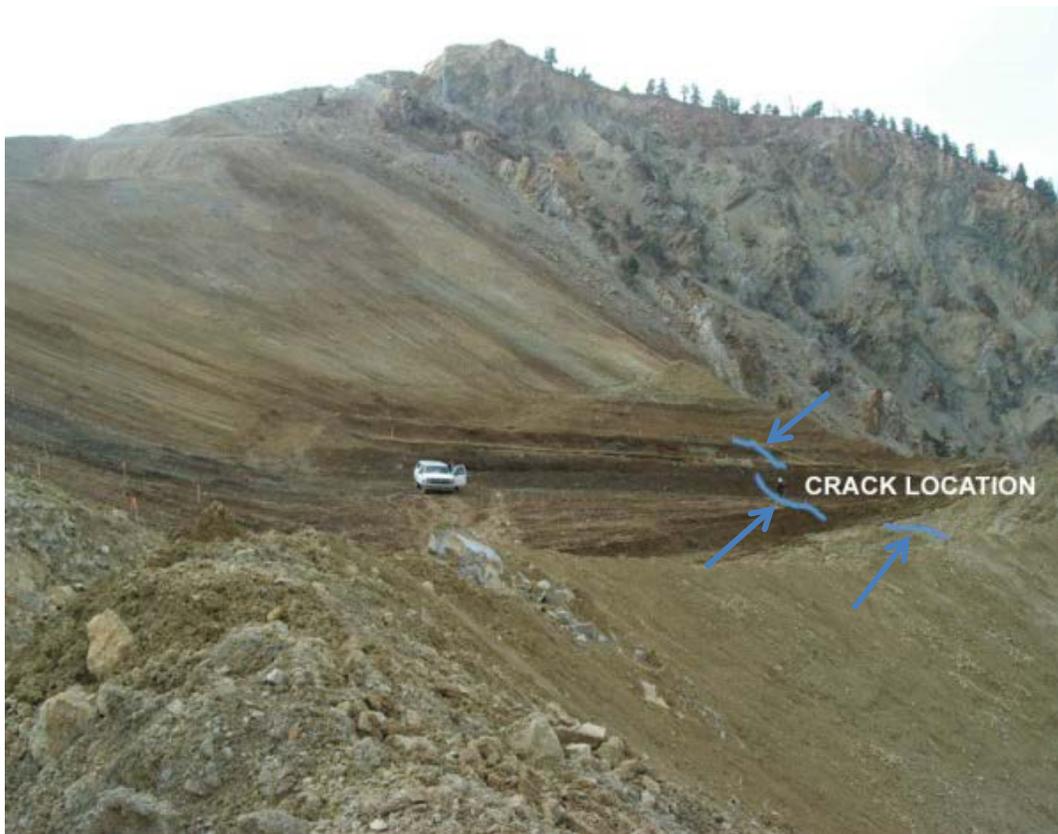
The progression of the crack across the trench may be seen in Figure 3. The slope angle at the time of failure may be seen in Figure 4. A bulge at the base of the slope was observed but the precise location of the bulge was undetermined. It was hypothesized that the bulge might be related to the toe kick-out of the slope failure. A photograph of the trench and some of the staked crack locations may be seen in Figure 1 through Figure 4. Figure 1 represents a plan view of the crack and shows the intersection with the original ground surface (orange squares), the location of the crack (red triangles), and the crest of the re-formed slope (triangles). The location of the 2D slice utilized for this numerical modeling study followed through the trench (and resulting field data collected) at the center of the slope.

Figure 3 Approximate crack locations from the side of the slope (highlighted in blue)

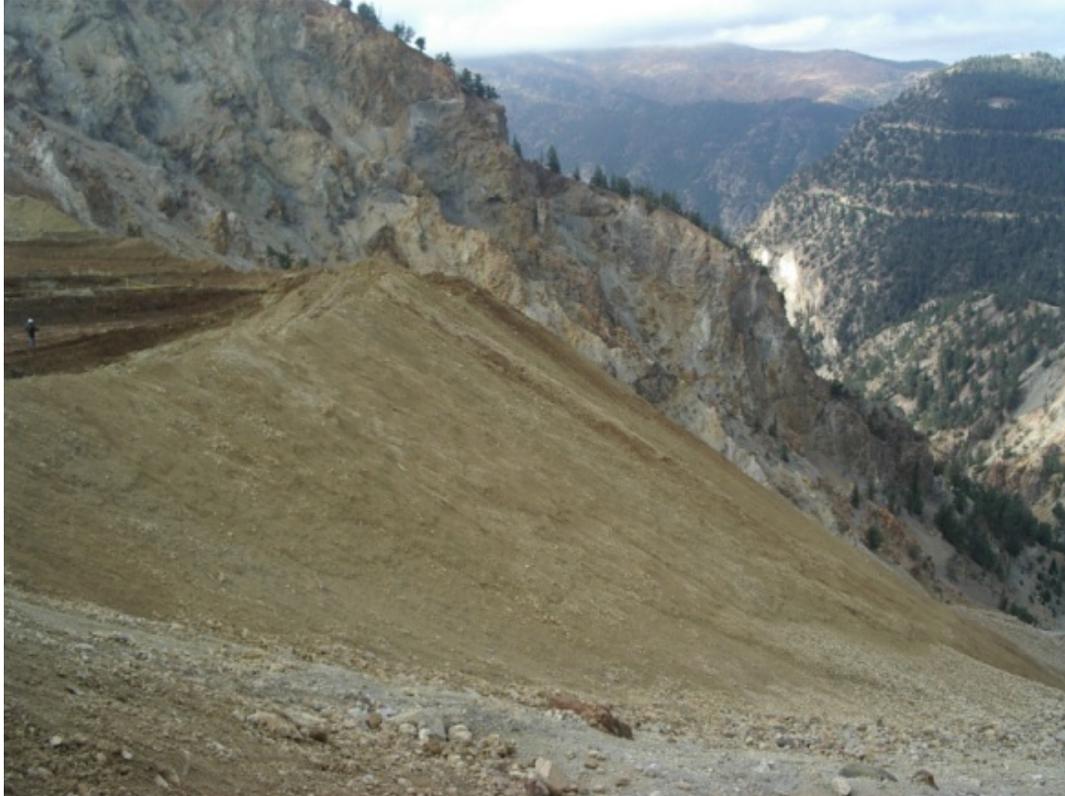
From survey points and field photographs it was possible to accurately identify the geometry of the upper level of the rock pile on which the trench was situated. The average slope was determined from photographs to be 40.5 degrees.

Figure 4 Photo showing the angle of the slope during crack formation

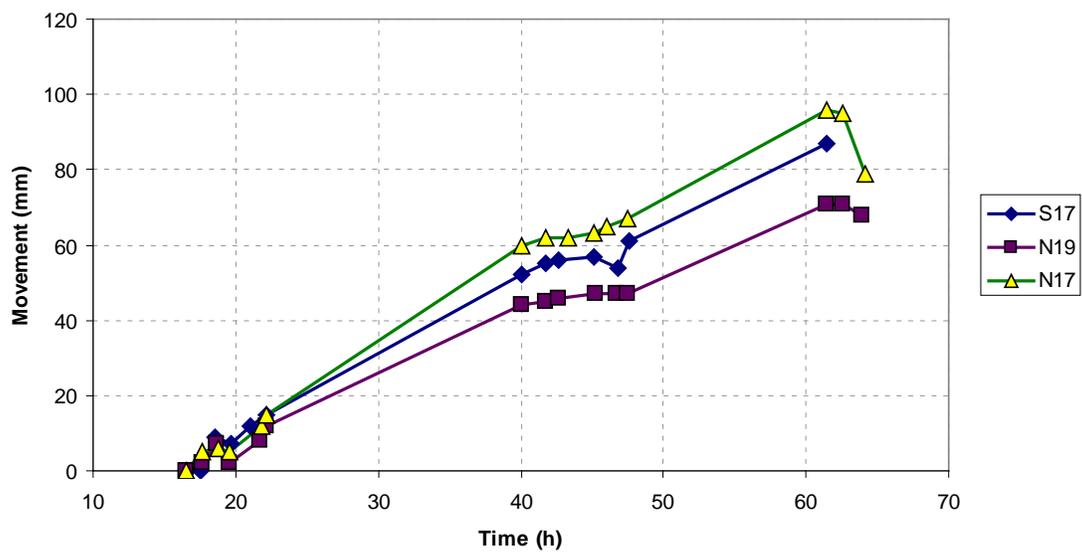
The crack separated a horizontal distance of 0.15-0.24 ft. from October 1 to October 4, 2004 and a vertical distance of 0.6-0.8 ft. The measurements are graphically displayed in Figure 5.

Figure 5 Plot of crack separation versus time on October 2-4, 2004 for identified sampling locations S17, N19, and N17 close to the trench

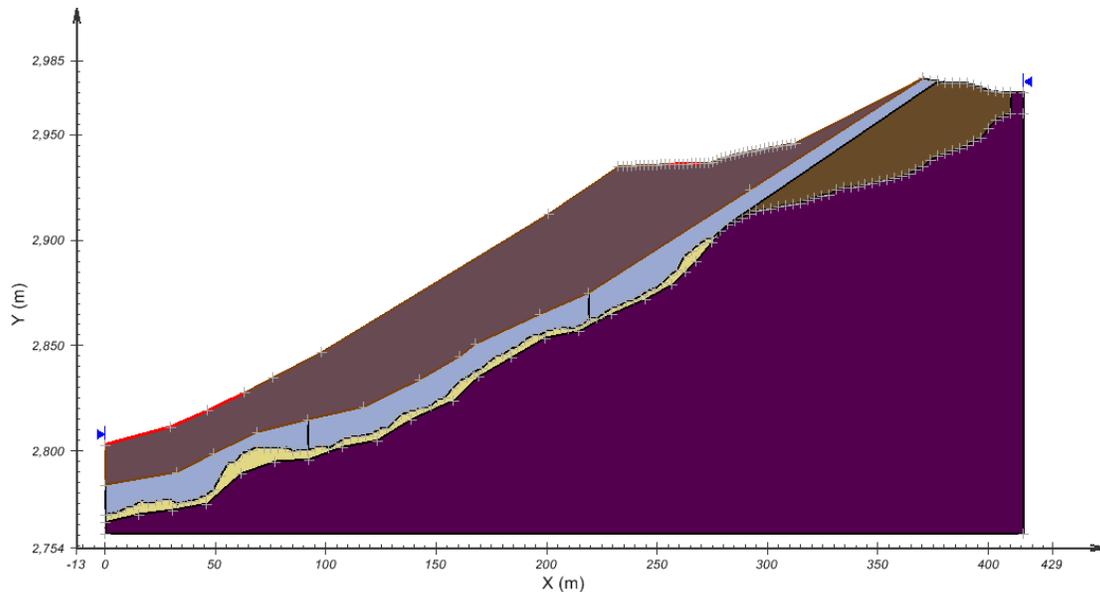
For the purposes of the back analysis, it was assumed the shear strength of the rock pile material is homogenous throughout the entire slope. It is also assumed that the slip surface does not go through bedrock and that the shear strength of the bedrock is significantly higher than that of the rock pile material. There is a weak soil layer between the bedrock and the rock pile material as reported in the Norwest (2004) report. It is assumed the shear strength of the rubble zone is less than that of the rock pile material. For the present analysis it is assumed that the colluvium and the rubble zone are combined into a single layer. The layers are combined because of the lack of data to justify a significant distinction between the layers. Combining the layers is also considered conservative in the present analysis. The finalized geometry utilized in the analysis may be seen in Figure 6.

Figure 6 Established geometry of the 2D cross-section through the center of the slope failure

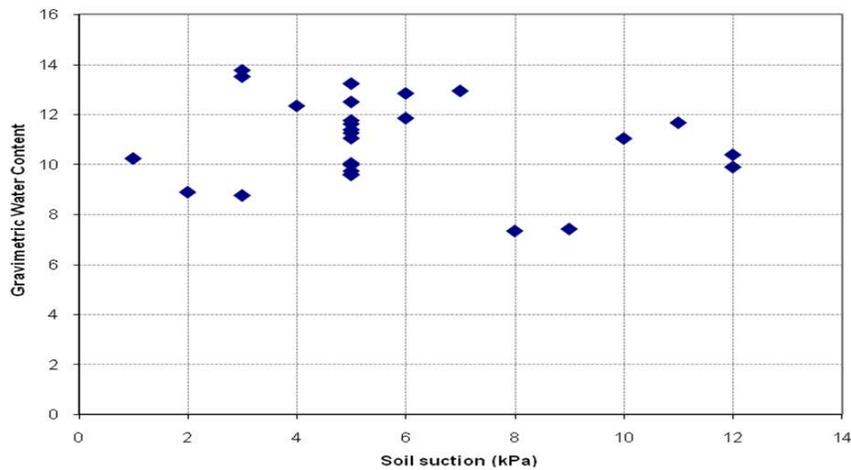
Tensiometer readings and gravimetric water contents were also taken along the crack on October 3, 2004. These readings illustrate moist conditions along the top of the crack at the time of failure (Figure 7).

Figure 7 Tensiometer readings taken along crack on October 3, 2004

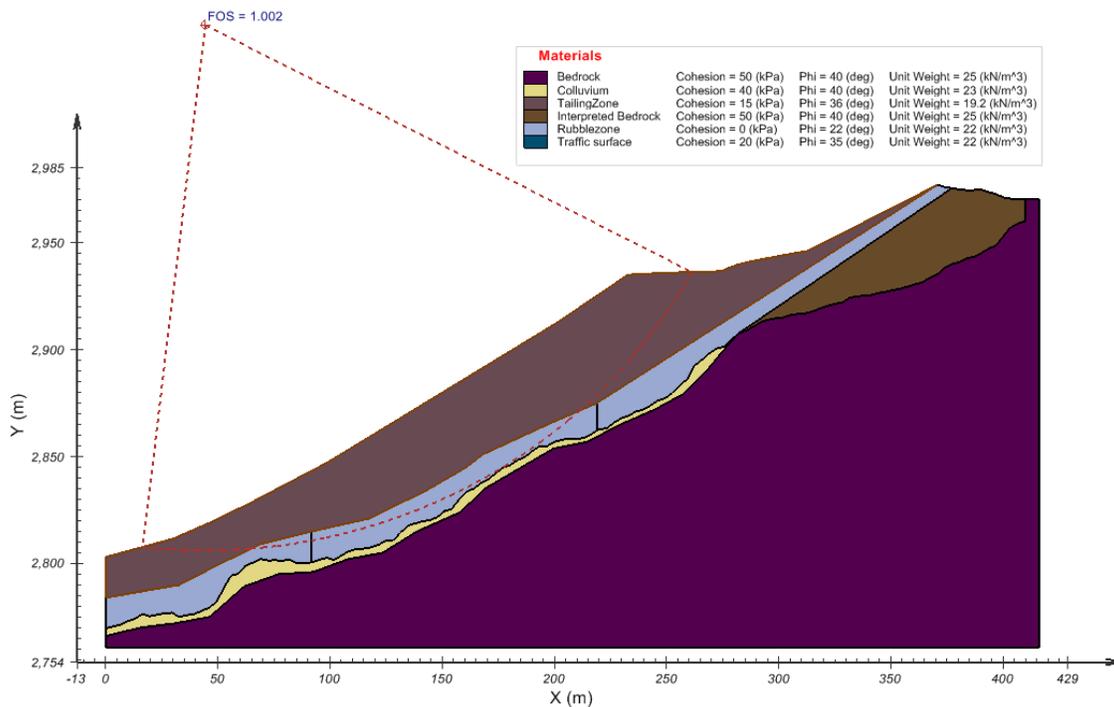
Measured peak strength friction angles for the rock pile material are between 36 to 47°. In the Case 1 scenario it is assumed that the rock pile material has strength values of cohesion = 15 kPa and a friction angle = 36°. The strength of the rubble zone is then reduced until the factor of safety of the critical slip surface falls below 1.0. The General Limit Equilibrium (GLE) method of slices was used in this analysis. An entry and exit trial-and-error methodology was used to identify the location of the critical slip surface. The entry point of the slip surface is known from the survey data. The exit point is approximated based on a combination of field observations of a bulge at the toe as well as a sensitivity slope stability analysis regarding the likely location of the slip surface. The results of a typical analysis may be seen in Figure 8.

Figure 8 Typical results of analysis of a potential failure through the rubble zone (SVSLOPE)

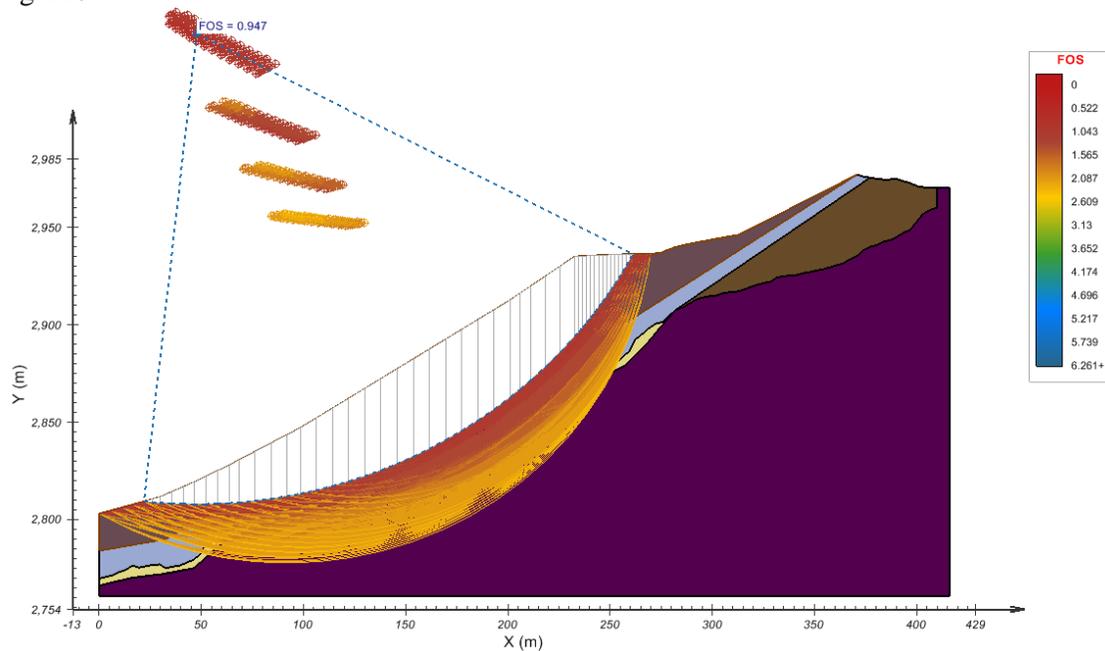
A series of model runs were performed in which the cohesion was assumed to be zero and the effective friction angle allowed to vary until a factor of safety just below 1.0 was achieved. Cohesion was subsequently added in the additional model runs and the effective friction angle varied until failure conditions were achieved. An example of the critical slip surface may be seen in Figure 9.

Figure 9 Example location of the critical slip surface for Case 2 (SVSLOPE)

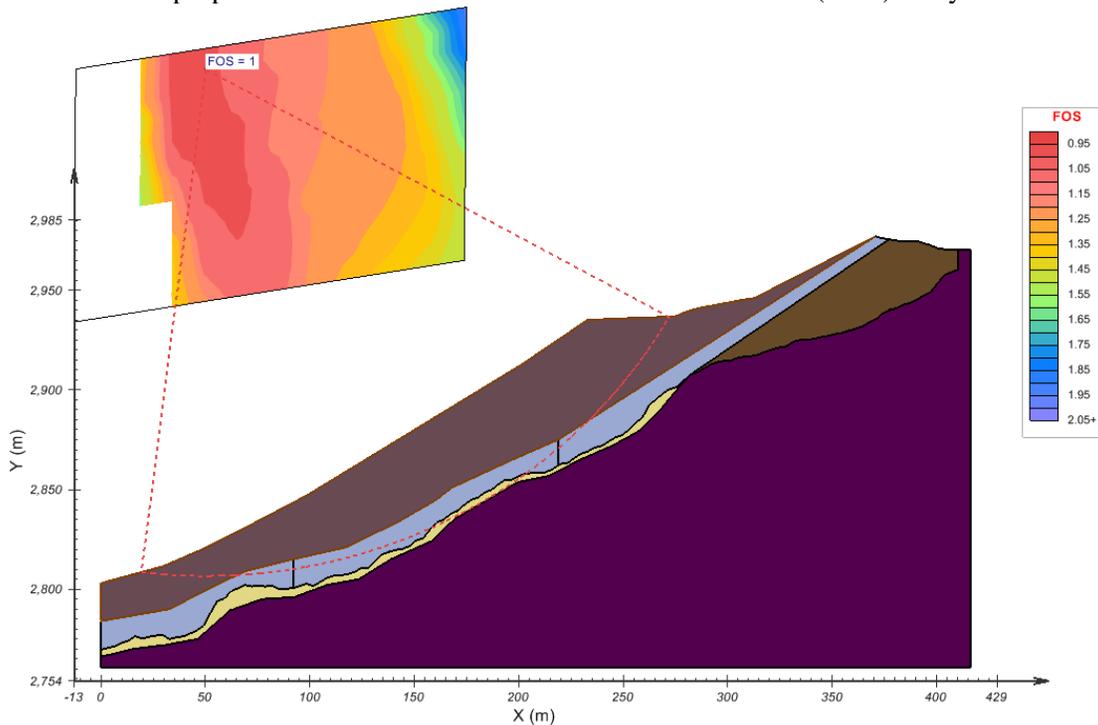
The selected slip surface location shown in Figure 10 is based on an approximate match of entry and exit points and results in the following material parameters:

The identified material parameters are reasonable and provide a level of continuity with measured laboratory and field results. The measured friction angles for *in situ* tests showed a lower limit value of 36 degrees. The friction angle for the colluvium / rubble zone is also consistent with the properties of the colluvium determined in the Norwest (2004) study.

Figure 10 Location of slip surface for weak rubble / colluviums (SVSLOPE)

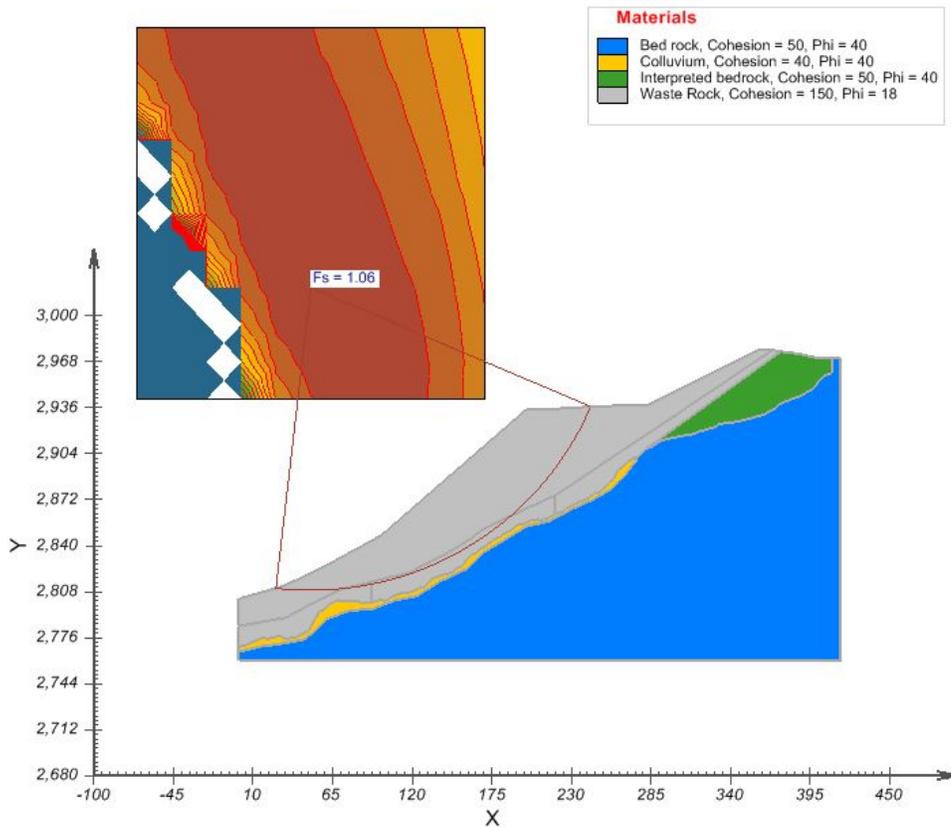
The resulting critical slip surface is very similar in location to the critical slip surface determined in Case 3 and may be seen in Figure 11. The soil parameters used to achieve this critical slip surface are quite different than obtained for Case 3 and are given below:

These parameters are unrealistic in comparison to site-measured parameters. The high cohesion values are needed in order to cause the CSS location to be deeper in the pile and match the observed exit point of the slip surface. It is reasonable to conclude the rock pile and rubble zones do not have the same material properties.

Figure 11 Resulting slip surface from a homogeneous model (SVSLOPE)
