# How a distressed quay wall could be moved back in place... using Plaxis

B. Simon, Terrasol

Chef de Baie 1 Quay was built in 1982 in La Rochelle harbour. It is 180m long and 23.5m high. It receives ships with cargoes of bulk timber and containers. It is an essential piece of the port facilities as it receives more than 30% of all quantities of wood and other similar products which are imported into France.

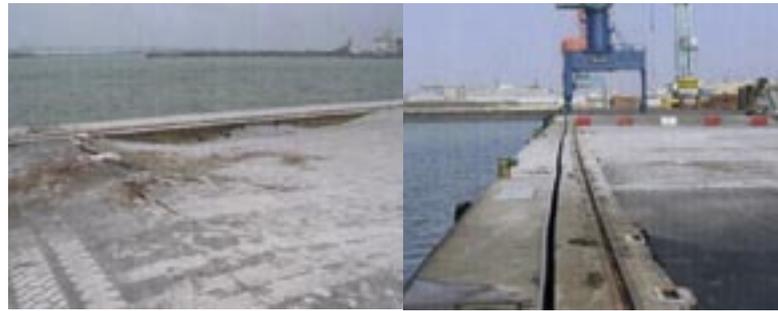
Defects appeared quite suddenly on 12<sup>th</sup> February 2001 between 12 noon and 1 p.m. without any witnesses. Misalignment of the rails and decimetric settlements of the platform were readily apparent. Horizontal displacement of the capping beam reached some 30 to 40cm on a 100m stretch.

Figure 2 and figure 3: Platform settlement and rail misalignment

Emergency backfilling in front of the wall could stop this progression and restore safety.

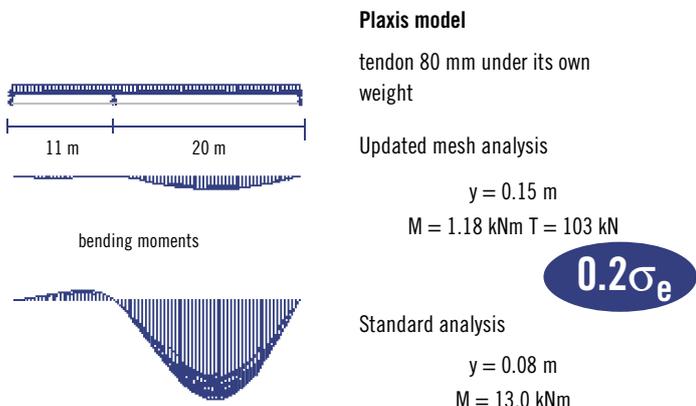
Figure 4: Hanging rod analysis

At first, it was decided to check the stresses in the tie rods before filling, when they simply hung between the front and back wall with one temporary support line in between. Only updated mesh analysis provides reliable results as can be seen in figure 4 where they are compared to results from standard analysis. Updated mesh analysis demonstrated that tie rods could be submitted to significant tensions, which combined with the bending stresses led to stresses as high as 20% of the tendon yield stress. A significant strength amount had thus already been consumed in that preliminary stage and this clearly should not have been neglected in the design.

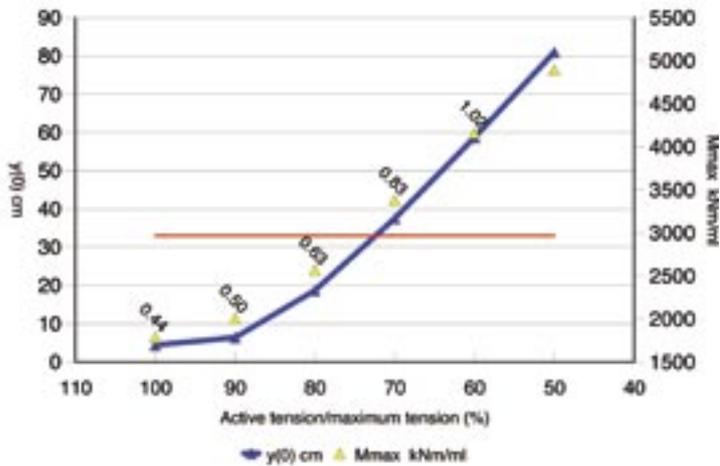
Figure 6: quay displacement and bending moment versus remaining tie-rod capacity

The same model was used to study how the displacement at the top of the wall evolved when the tie rod tension was decreased by steps. This showed that tie rod reaction had to be kept at around 75% of the installed capacity to account for displacement around 30 to 40cm as observed just before emergency filling. Thus it could be concluded that not all the tie rods were broken or else the displacements would have been much higher. In addition the Plaxis model pointed out that maximum stress in the front tubular piles remained less than 75% of yield stress despite the amplitude of their displacement.

These piles could then still be reused. Checks of the structural integrity of other quay components led to the conclusion that the concrete capping beam could also be reused while the transverse and rear beams which suffered too much cracking had to be rebuilt.

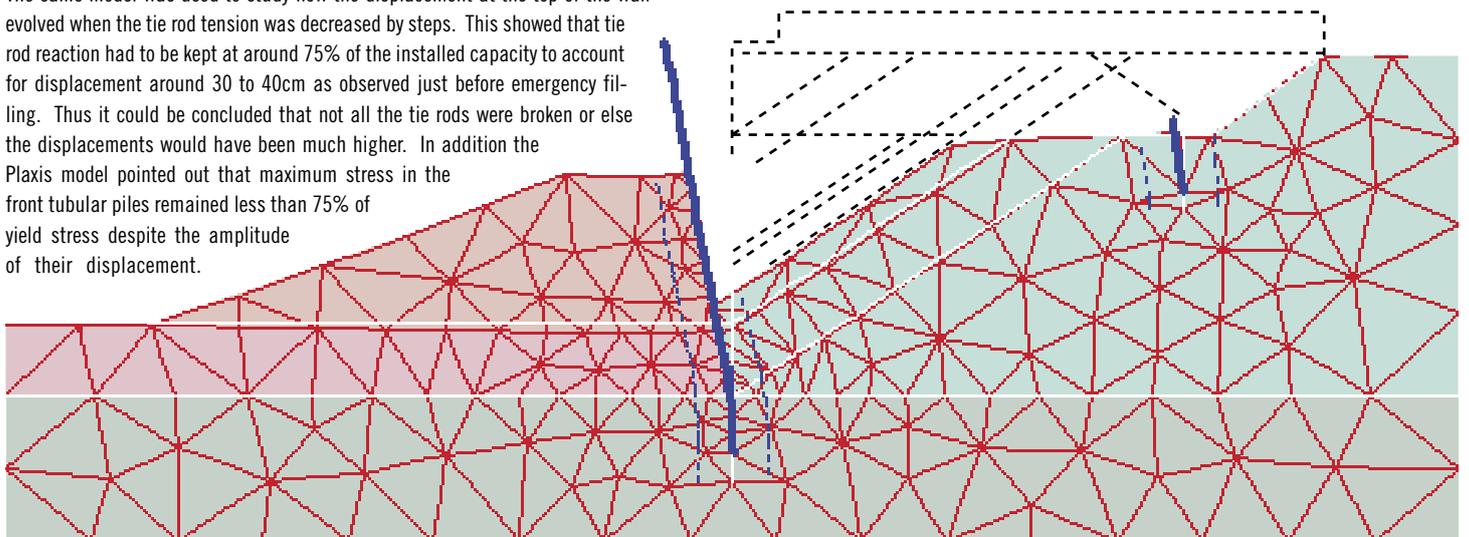
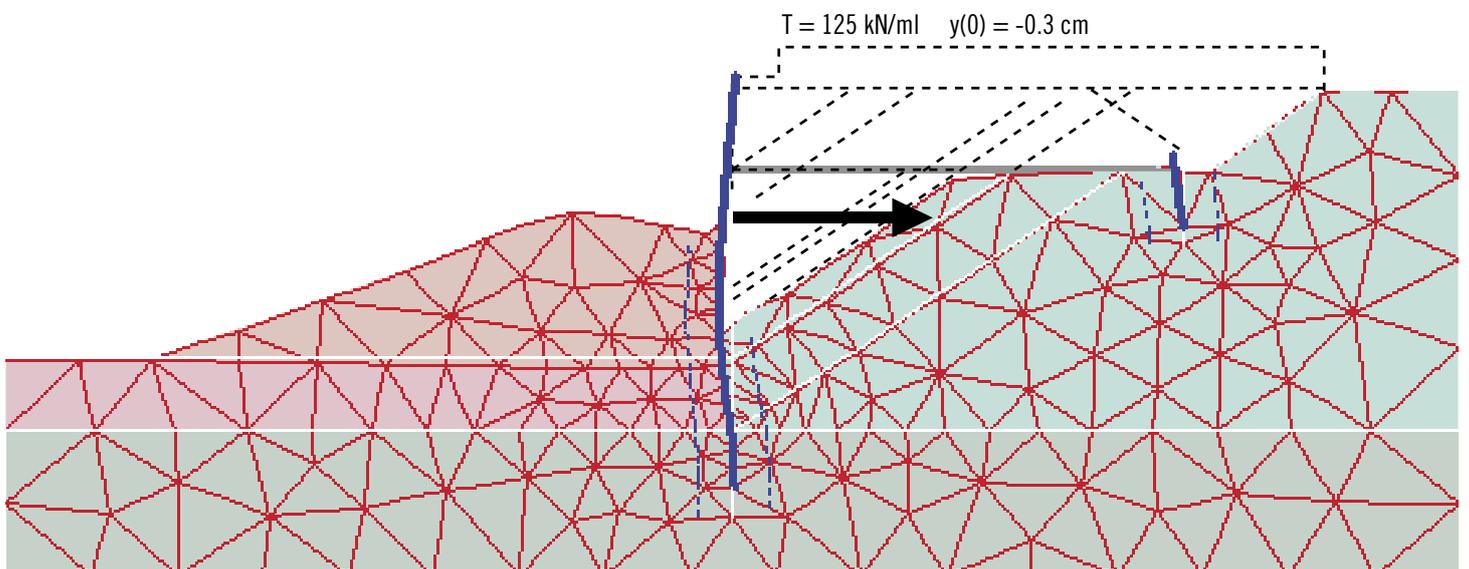
Figures 7a and 7b: Modelling the repair actions

The agreement found between the numerical model and the recorded displacements led us to consider that the model could help exploring various solutions for moving back the wall. This complementary study proved the wall alignment could be restored by combining controlled excavation behind the wall, down to elevation -7.6 CM, and pre-stressing the temporary tie anchors. Tension forces varied between 125 kN/ml and 145 per ml to move the front line between 0.6cm and 1.8cm back its theoretical initial position.

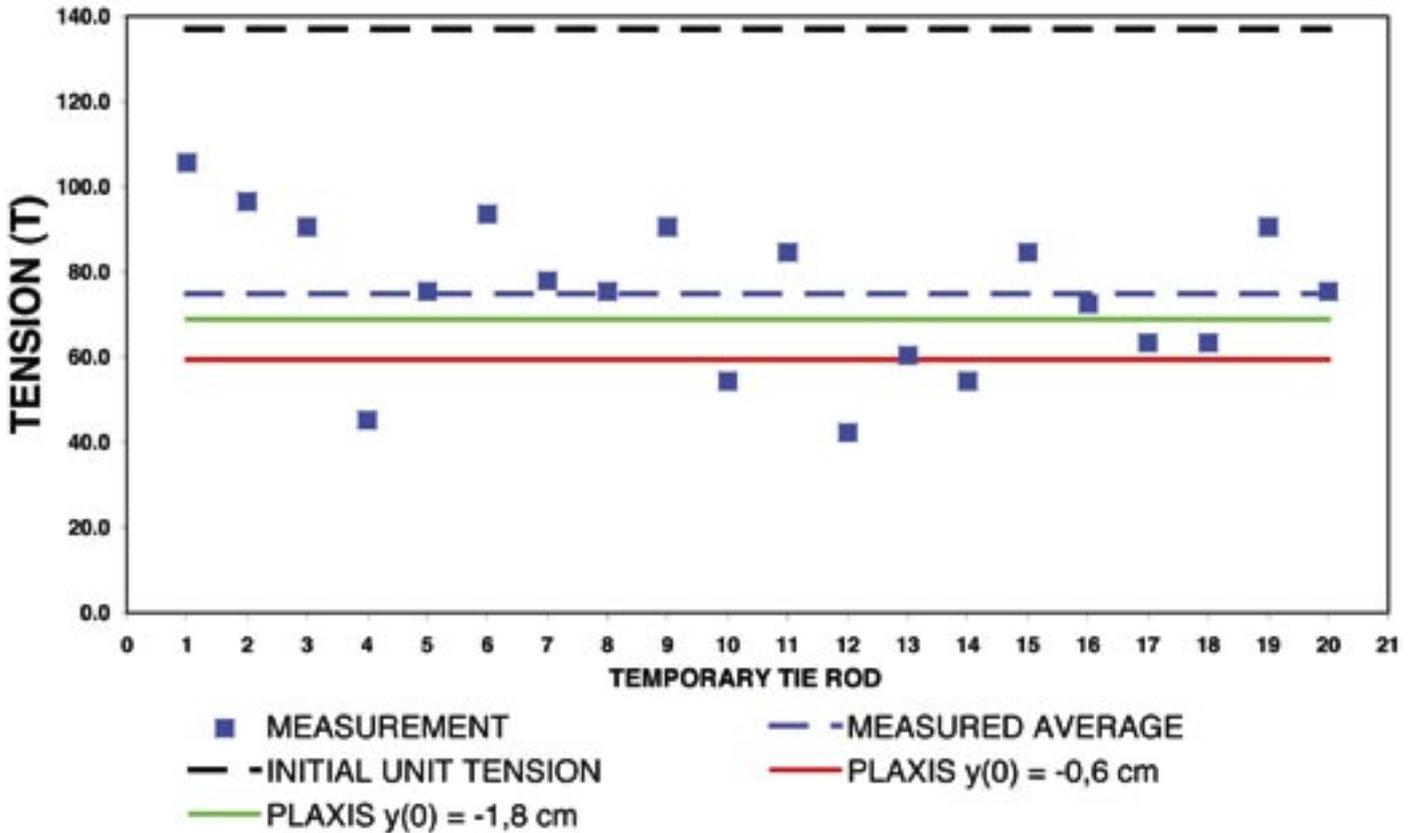
Figure 8: measured tensions in the temporary tie-rods

Measured tensions in the temporary tie rods at final stage are plotted in figure 8. Average value is slightly higher than the estimated tension for a final displacement of 1.8cm beyond the theoretical line. Since achieved displacement was slightly more (between -2 and -3cm), Plaxis predicted tension values match closely the observations.

- Temporary fill to improve passive thrust in front of rear anchoring wall
- Temporary tie rods (2 tie rods every 5 piles : one per 4.75 m)
- Controlled excavation down to -7.6 CM together with tensioning of the temporary tie rods (in successive runs)
- Rebuilding the rear beam (piles and transverse beams)
