Second Pier North of Abutment No. 1

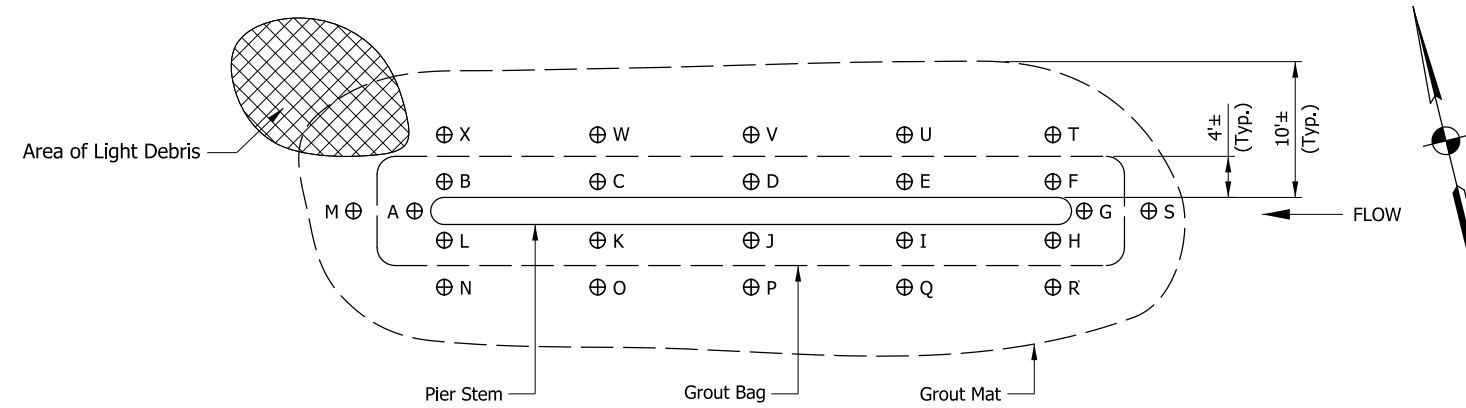
PLAN  
Not to Scale

Material: Concrete Wall Pier  
Cracks: None noted  
Impact Damage: None noted  
Channel Bottom Material: Silt  
Scour: None noted  
Exposed Footing: None noted  
Exposed Foundation Piling: None noted  
Condition of Pier (Mud-line to Water-line): Fair  
Notes: Flow = 3.7 ft/sec; Deep scaling, spalls, and pop-outs noted (see drawing)

Random Area of Patching
