Second Pier North of Abutment No. 1

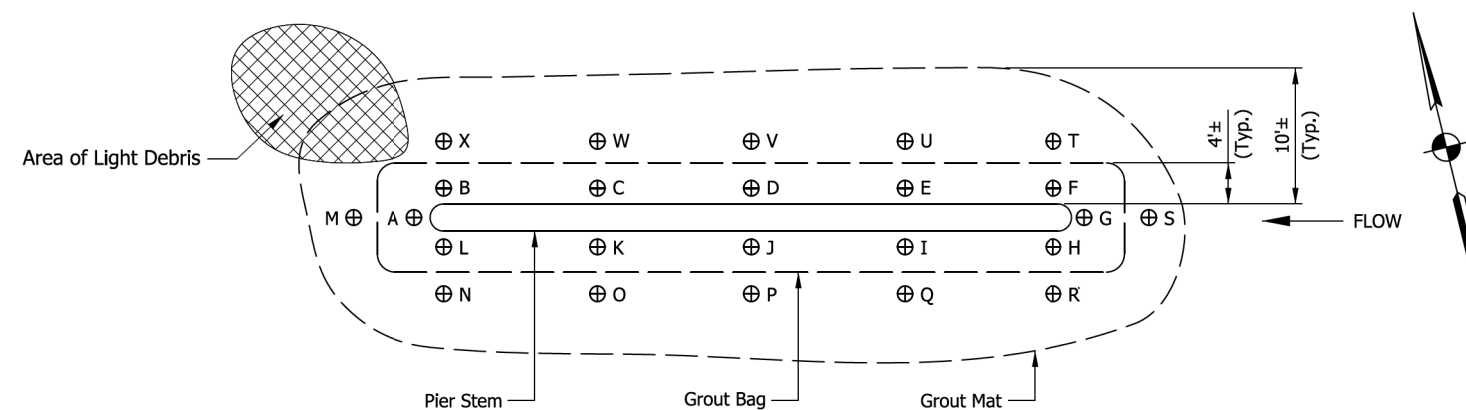
PLAN
Not to Scale

Material: Concrete Wall Pier
Cracks: None noted
Impact Damage: None noted
Channel Bottom Material: Silt
Scour: None noted
Exposed Footing: None noted
Exposed Foundation Piling: None noted
Condition of Pier (Mud-line to Water-line): Fair
Notes: Flow = 3.7 ft/sec; Deep scaling, spalls, and pop-outs noted (see drawing)
