## USE OF INTERFACE ELEMENT FOR SIMULATION OF BRECCIA RESLIDING ON CLAYSTONE

Author: Paulus P. Rahardjo, Parahyangan Catholic University, Bandung, Indonesia

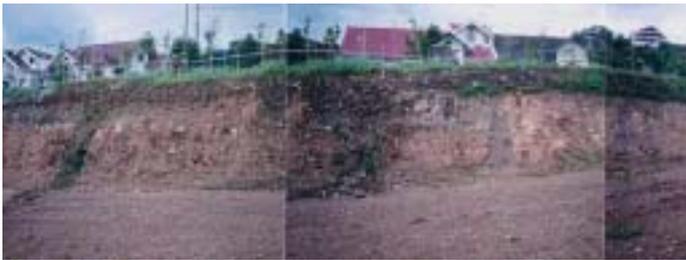
Figure 1: Excavation in the breccia layer

In the project site where new road was to be constructed, an excavation of 4.0 m depth was conducted. This excavation was initially thought to be the cause of the landslides. Spring water appeared at the toe of the slope and the excavation shows the severely weathered breccia. However, this initial opinion cannot be justified due to the fact that the building on top of the excavation still remains in good condition. No significant damage was noticed and the steep slope looks very stable. Figure 1. shows this phenomenon.

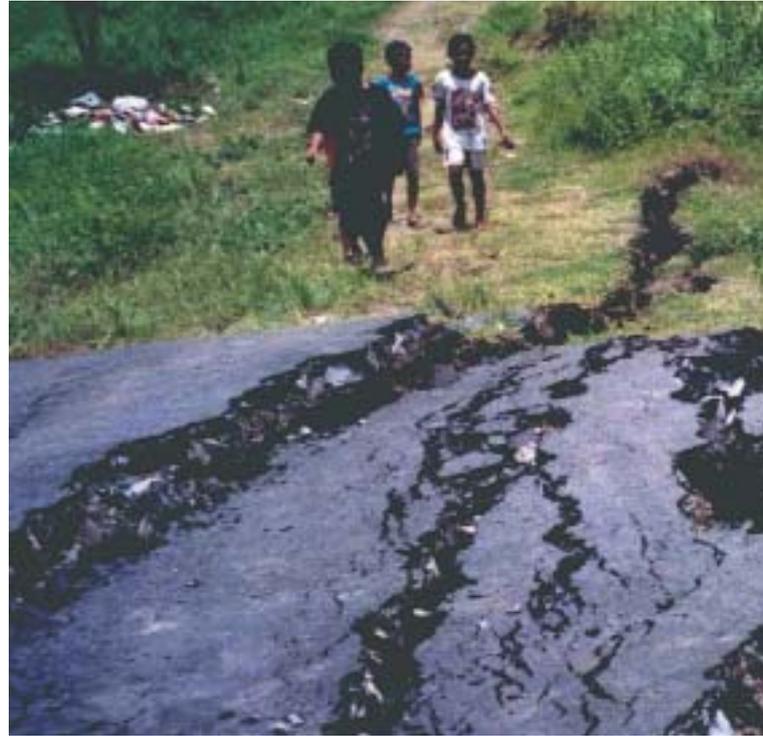
Figure 2: Damages due to subsidence

The movement started early in the morning when about 25 cm of sudden drop initialized the whole movement. Afterward, subsidence occurred systematically reaching 3.5 m in about 10 hours. A number of cracks appeared in this area and water sprang out through gaps in the cracking ground. This phenomenon caused several houses tilt and crack and by the end of the day the whole infrastructure was devastated.

The subsidence was localized in the fill area where a number of infrastructure including roads, drainage and electric towers were damaged. Since the subsidence caused 3.5 m difference in elevation, the connecting road tore out in certain patterns either laterally across the road or longitudinally. Figure 2 and Figure 3 shows severe damage of the infrastructure.

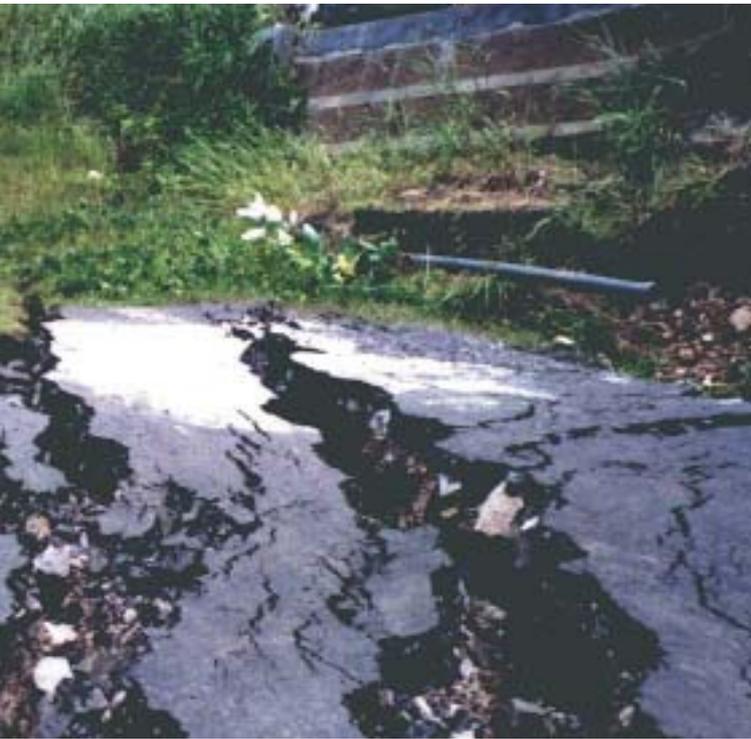
Figure 4: Ground cracking

Figure 4 shows ground cracking parallel to the road and Figure 5 shows how the land elevation moved downwards about 3.5 m in one day. The direction of the cracking indicated that the land experienced lateral spreading. However, at this point the real mechanism was not known until re-measurement of the contour was conducted.
