Stability Analysis of the Red River Dike: The Past to the Present

Pham Quang Tu, P.H.A.J.M van Gelder, Technical University of Delft, The Netherlands
 Trinh Minh Thub, Hanoi Water Resources University

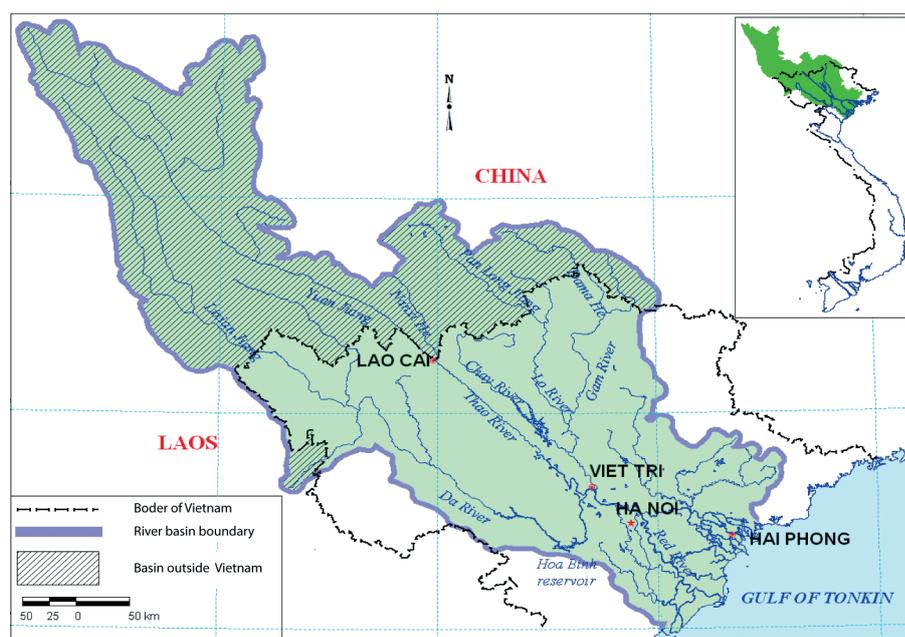
Figure 1: Red river basin (from Khoi [2010])

➤ The Red River (known as Song Hong in Vietnamese) flows from the mountain areas of Southern China to the Gulf of Tonkin (East Sea) with a total length of over 1150km (the length in Vietnam's area is about 510km), as seen in Figure 1. The River is the biggest one in the northern part of Vietnam with the total dike length of nearly 1700km that take up more than a half of the length of the dike systems of the delta. The dikes are divided into different parts due to their specifically protective functions, and each part will follow a different level of safety. In the Hanoi area, the length of dikes of grade 1 and "special"^{*1} is around 250km in a total of 470km (DDMFC, 2009), (see Figure 2). In this part, four periods of dike development will be discussed to give readers an overview of dike rehabilitation for hundreds of years ago.

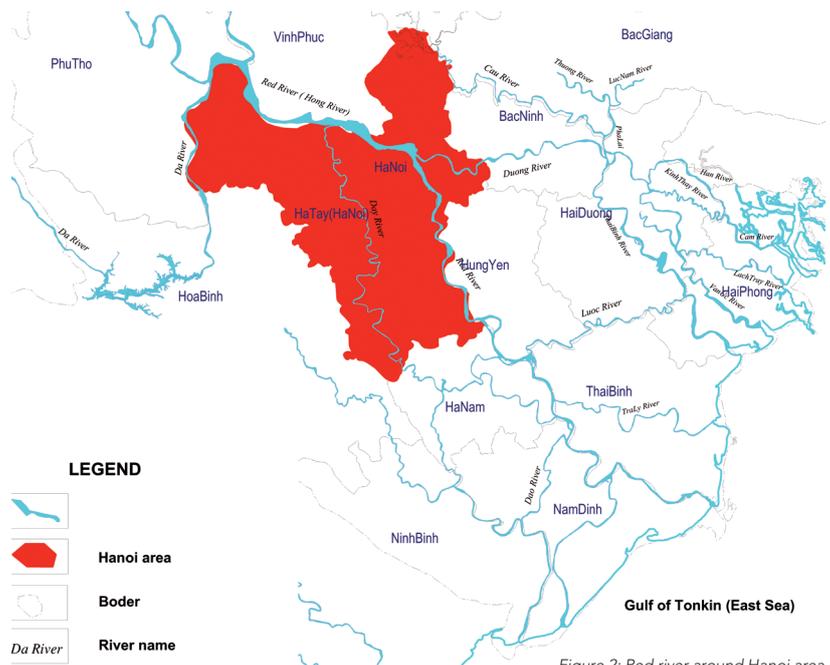
Figure 2: Red river around Hanoi area

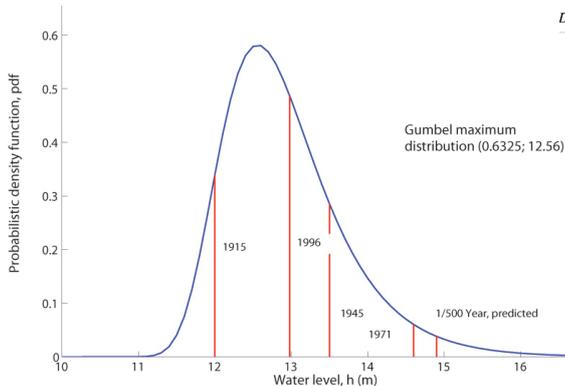
Figure 3: Probability distribution of maximum water level

with the level of dike crest of 10.5m, and the safety factor (Msf) minimizes at the predicted situation with a flood frequency of 1/500 year. However, in terms of flood management, the dike in the year 1893 might be safe at the water level frequency of 1/1 year (see Figure 3). It means that if there is a flood with a higher water level of 10.5m, dikes could failed by the overflowing and erosion of the inner slope, even if its safety factor reaches 1.54. In 1971, the dike could be able to withstand in the critical states, e.g., Msf ~ 1. It showed reasonable evidence for dike assessments around Hanoi at that time with some dike sections at the birth of collapse (see FPD, 2000). At the predicted flood level of 1/500 year, the water level is not raised freely because the Red River discharge is redistributed by the reservoir systems at the upstream rivers. However, the flood duration increases dramatically, from 5 days (in 1893) to 16 days (in the predicted flood of 1/500 year) and dikes are also at the risk of critical situations. If

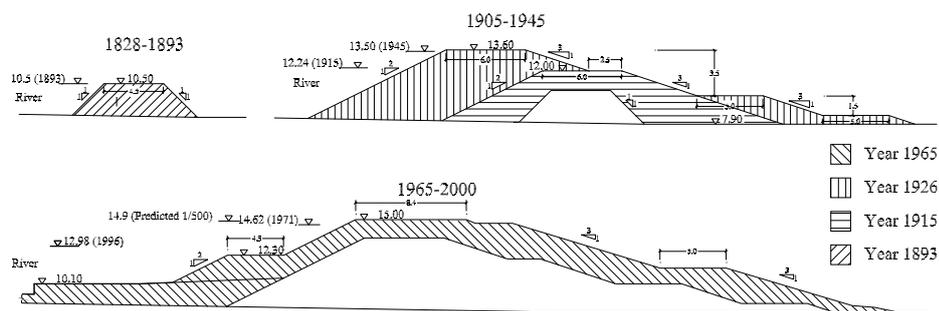
Figure 4: Typical dike strengthen strategies

Secondly, dike geometry was collected from the local dike boards and historical documents. In the 19th century-empirical period-there were no drawings of dike cross sections due to the limitations of both scientific knowledge and poor archives of works. In the period dominated by the French, the dike dimensions were formulated based on historical documents and updated with research works (Phan, 1985; Gauthier, 1930; Monsieur and Dominique, 1991). The data including documents of dikes have been properly protected, so all typical sections relating to each dike program are quite clear and available now. The strategies of dike rehabilitation are described geometrically in Figure 4.

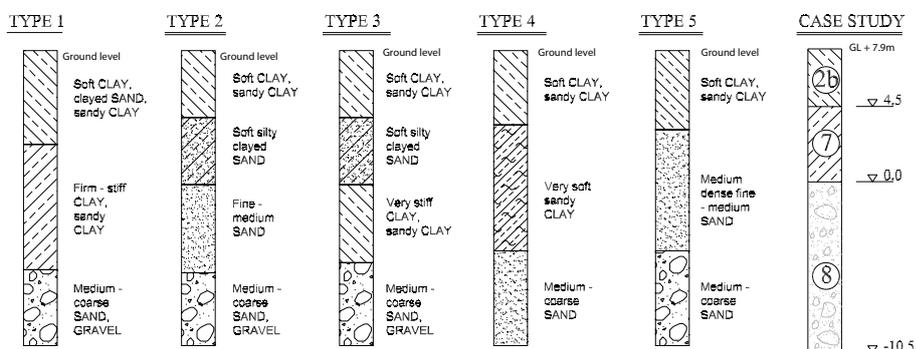
Figure 5: Typical geotechnical profiles

Thirdly, from geotechnical investigations, the profiles of soil are illustrated with different typical combinations. Nguyen (1999) summarized the four possible cross sections for analysis in the project of Red River dike rehabilitation. Tran (2012) also recommended five types of ground conditions for the assessment of the Red River dikes. In fact, both the studies are nearly similar, although the latter described more clearly the influence of the silty fine sand layer to the dike stability. In this paper, the authors take in to account the 1st profile for

calculation; the 4th and the 5th types seem to be more dangerous for dike embankments, but these profiles are vanished from the study area and they will be discussed in another report (see Figure 5). Finally, soil properties were selected from the report of Geotechnical investigation, which were carried out in 1994 for the ADB project (HEC1, 1994). The dike embankment is represented by different compaction ratios which is assumed varying from $K < 0.80$ (in 1890s) to $K \sim 0.95$ (currently). The soils of embankment have been remoulded in the laboratory with the mentioned compaction ratios, then the strength and the compression were determined by direct shear test and oedometer test. In fact, the soil parameters (of layers 2b, 7, 8 following HEC1 (1994)) could not be determined at the construction period, for instance during 1890s, 1915, 1945, etc. It is assumed that the changes of soil parameters are disregarded in this case study.

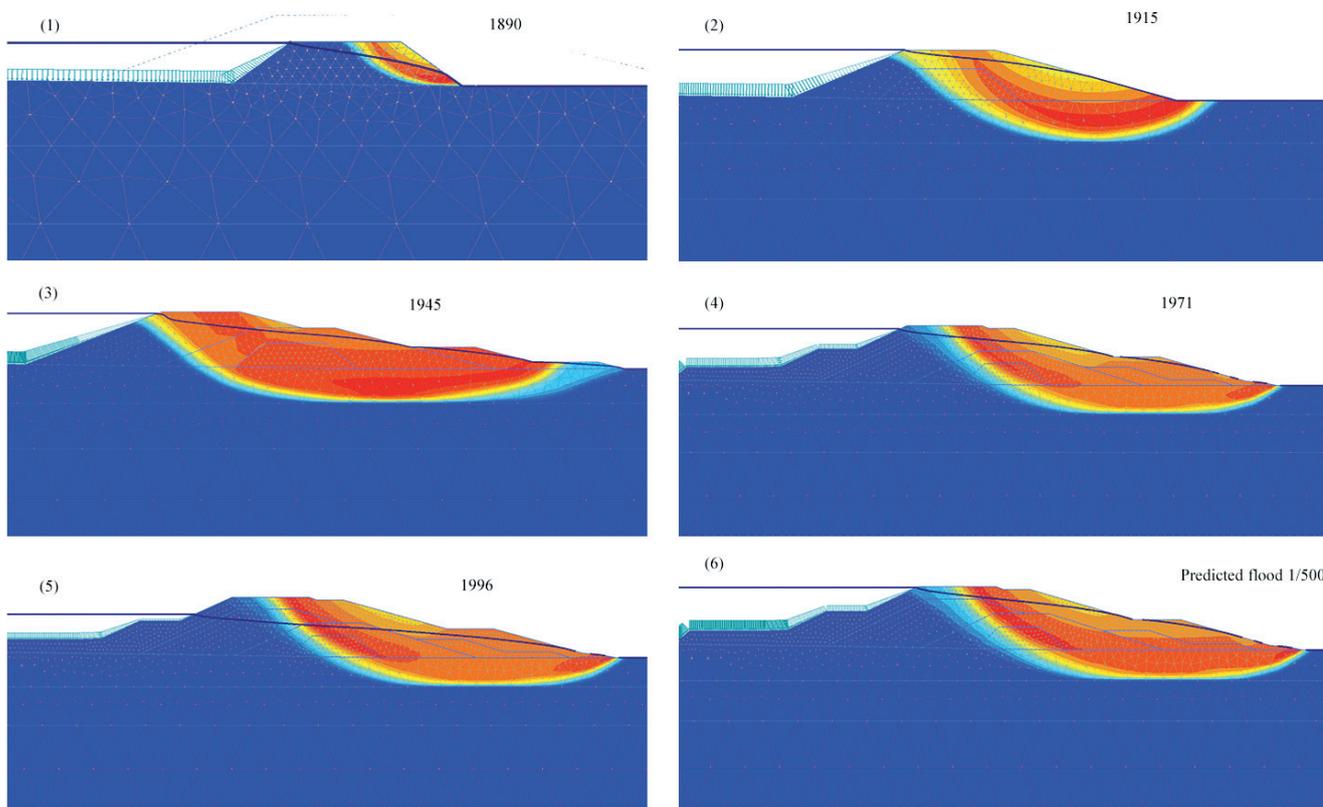
Figure 6: Stability of dikes vs construction stages

Figure 6 shows the results of the safety calculation phases, and the plastic zones enlarge depending on both the dike geometry and the flood water levels. The phreatic levels reach the critical situation in most cases, and the dike embankments were saturated. The level of dike crest has increased many times with different construction methods (Phan, 1985). In this paper, only four different geometry of dikes are selected because they were dealing with the typical flood waves and the major project of dike rehabilitation.

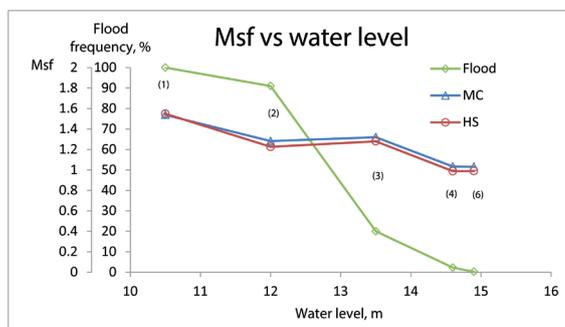
Figure 7: Msf vs Material Models and flood frequency

Dike failure was observed twice in the year 1915 at the study location, comparing to eight cases of dike failure during the 20th century (Ha, 2010), and where the overflowing was the dominant mechanism of failure. Table 4 and Figure 7 show that we have the maximum of dike safety in 1893

Comparing the material models of MC and HS, we can see from Figure 7 that the former has a higher value of M_{sf} than that of the latter. A possible explanation is that the HS model mobilizes soil strength lower than that of the MC model (Brinkgreve, 2009); in this case, HS model is preferable to application.

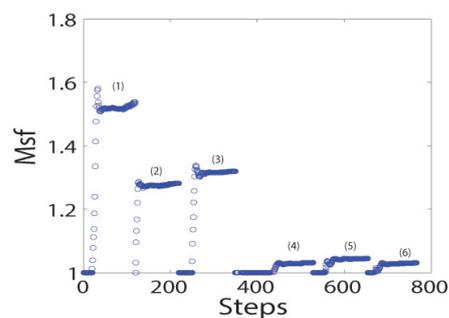
Figure 8: Msf vs steps calculation of MC model
