# Back analysis of the Goat Hill North slope failure

**ABSTRACT:** This paper presents the study of a crack that formed on the Goat Hill North Waste Rock Pile of the Molycorp Questa Site. The crack formed during the re-grading of the slope and represented an excellent way to benchmark a numerical model to a failure condition at the site. With the back-analysis it was possible to use a geotechnical software package to back-analyze material parameters based upon possible modes of failure. The back-analysis of the slope failure indicated there are two possible modes of failure: i) a deep-seated failure through a relatively weak layer (rubble or colluvium layers) or ii) failure through the rock pile material. It appears unlikely that the crack observed on October 2004 is due to a failure plane through rock pile material alone. If this were the case, the resulting model-determined soil parameters ( $\phi = 18^\circ$ , cohesion = 150 kPa) differ significantly from the *in situ* testing program. It appears likely that the observed slope failure was the result of sliding along a deep-seated weak layer beneath the rock pile material and above the bedrock layers. The resulting material para

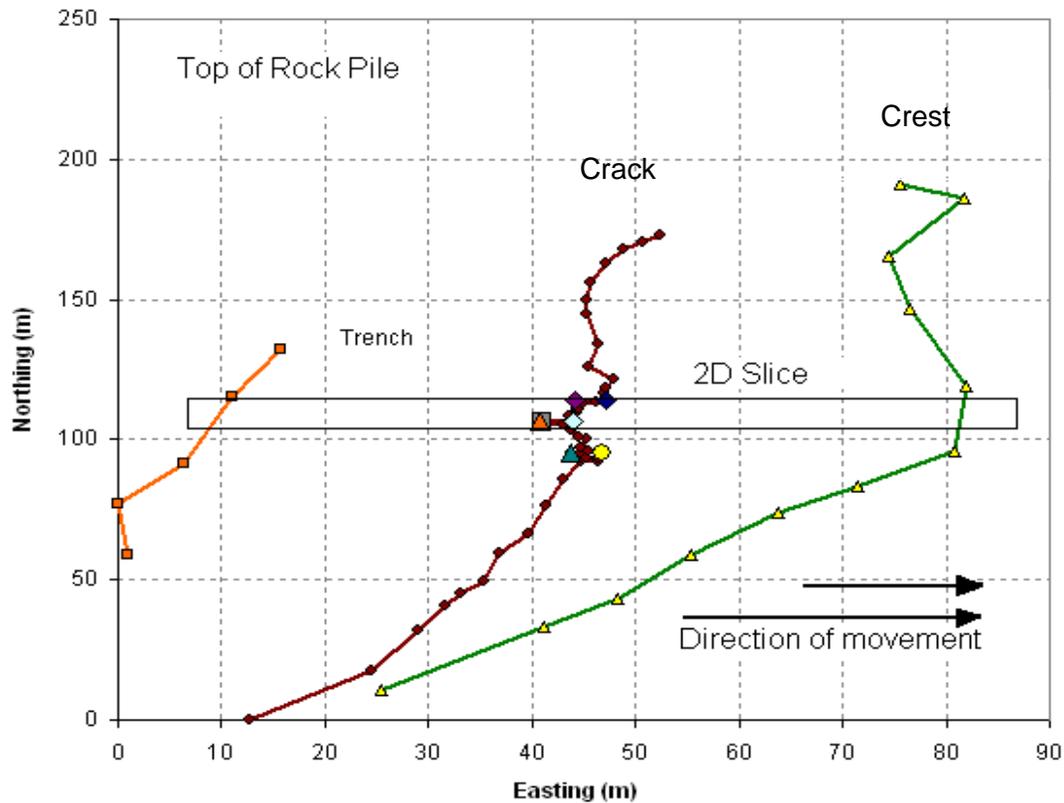
The location of the crack, the lip of the slope, and the intersection point with the 2:1 slope was surveyed by Molycorp personnel. The crack was also widening at a rate that was measured by Molycorp personnel. The data was later transferred to the New Mexico Tech (NMT) database. A plan view of the survey locations may be seen in Figure 1.

Figure 1. Plan view of the crest along with the location of the cross-section for 2D slope stability back calculations (UTM-Northing of 4062128).
