# How a distressed quay wall could be moved back in place... using Plaxis

B. Simon, Terrasol

Chef de Baie 1 Quay was built in 1982 in La Rochelle harbour. It is 180m long and 23.5m high. It receives ships with cargoes of bulk timber and containers. It is an essential piece of the port facilities as it receives more than 30% of all quantities of wood and other similar products which are imported into France.

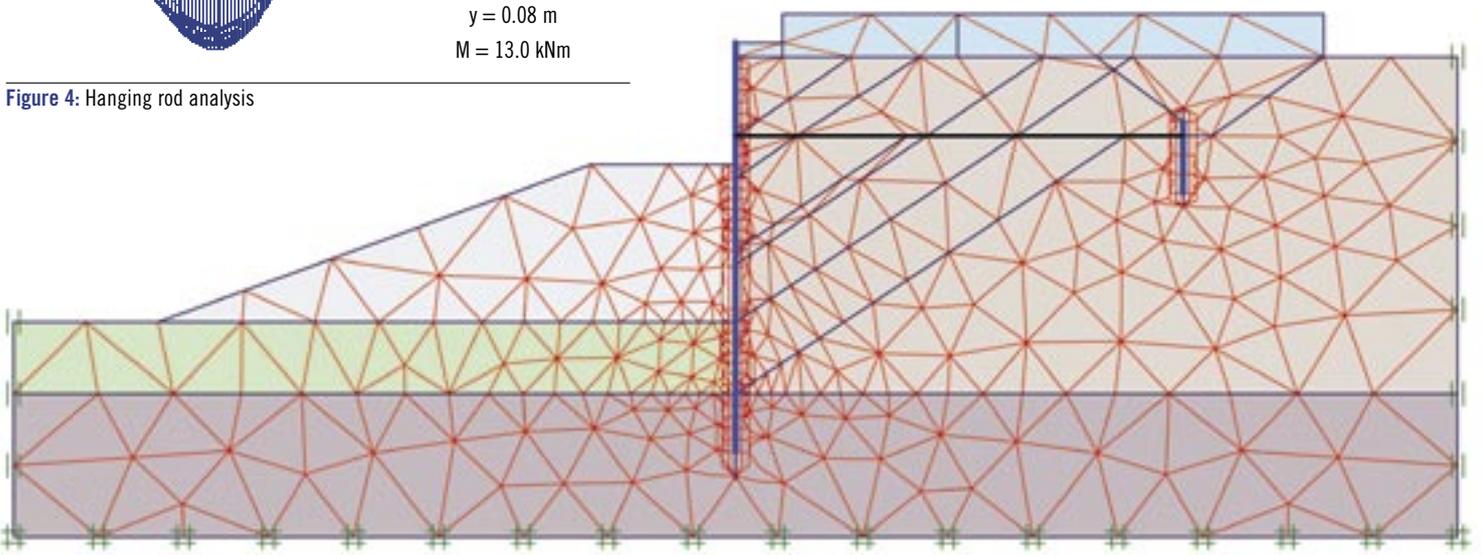
Figure 5: Plaxis model of the quay

A comparison was made between Plaxis calculations assuming tie rods acting either as node to node anchors or as geogrids with the same axial stiffness per ml. In the first case no interaction is assumed between fill and tendons while the latter assumes a complete interaction where tendons are carrying the full weight of overlying fill. The model neglecting fill/tie rod interaction led to less horizontal displacement with higher stresses found in the front piles.

Ymax (cm)	M+ (kNm/ml)	M- (kNm/ml)	T (kN/ml)
Subgrade reaction model	8.4	1820	2280	650
Plaxis model				
without interaction	9.4	1480	2160	623
with interaction	7.5	1265	1820	771

The same model was used to study how the displacement at the top of the wall evolved when the tie rod tension was decreased by steps. This showed that tie rod reaction had to be kept at around 75% of the installed capacity to account for displacement around 30 to 40cm as observed just before emergency filling. Thus it could be concluded that not all the tie rods were broken or else the displacements would have been much higher. In addition the Plaxis model pointed out that maximum stress in the front tubular piles remained less than 75% of yield stress despite the amplitude of their displacement.

The agreement found between the numerical model and the recorded displacements led us to consider that the model could help exploring various solutions for moving back the wall. This complementary study proved the wall alignment could be restored by combining controlled excavation behind the wall, down to elevation -7.6 CM, and pre-stressing the temporary tie anchors. Tension forces varied between 125 kN/ml and 145 per ml to move the front line between 0.6cm and 1.8cm back its theoretical initial position.
